# **EXHIBIT 3**

ROBINSON AND ASSOCIATES, L.L.C.

Re: Vernell B. Morris Case

The following is a summary of the activities and results to date in the reconstruction of the September 02, 2004 accident involving Vernel B. Morris, driving a 1998 Kenworth tractor and Edward N. Thompson, driving a 1995 Peterbilt tractor. The accident occurred on Interstate 85 northbound, between Macon County Road 30 and Macon County Road 93, in Macon County, Alabama.

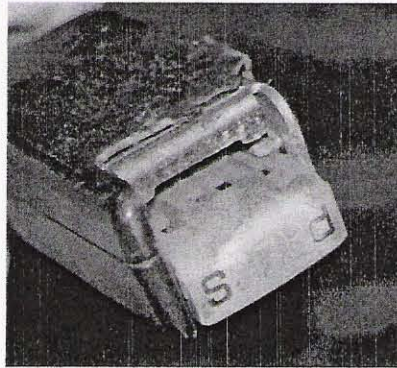
**Photo #1**

This determination was made from an examination of the safety belt latch, the driver seat, and the safety belt. Photo #1 depicts the latch mechanism from the seatbelt, which was more probably than not destroyed from the force exerted on the belt due to the collision between the two trucks. The seatbelt latch is on the driver's right, and the vehicle rolled onto the driver's left. This strongly indicates that it is more probable than not, that damage resulted from the collision force between the trucks, rather than simply breaking due to the nearly static stress on the belt when the vehicle rolled.

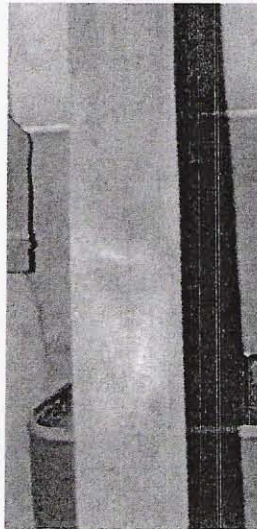
**Photo #2**

In addition to the latch, the seatbelt itself showed obvious signs of excessive loading, or force being applied to the belt that stretched it. Photo #2 shows the shiny areas where the belt was stretched and rubbed by the latch plate. Moreover, the seatbelt was locked in an extended position, not the rewound position, showing that it was more probably than not being worn at the time of the most severe impact.

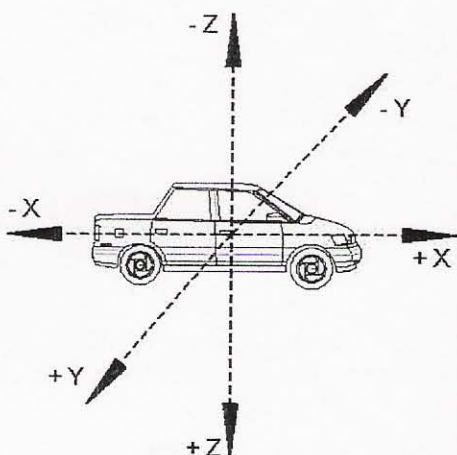
Upon inspection of the cab of the 1998 Kenworth, the driver seat was observed to be pushed up (from the floor) and forward toward the steering wheel, that is, deformation was experienced along the negative z axis (upwards, relative to the normal upright position of the truck) and along the positive x-axis (the normal forward direction of travel), and also along the negative y-axis (toward the left, or driver side of the truck). Photo #3 depicts the position of the driver seat when it was inspected, and a Cartesian coordinate system for reference.

The position of the seat and the fact that the deformation is most severe in the negative z and positive x directions shows clearly that the deformation is undoubtedly the result of the collision between the two trucks, not the result of the rollover experienced by the Kenworth just prior to the collision. The position of the seat corresponds to the pattern of injury documented by the Alabama Department of Forensic Sciences. According to the Autopsy Report, bruising was located at the anterior chest wall and lower abdominal wall, fractures of ribs #1-5 on the right, and ribs #1-7 on the left. Also noted was a lacerated spleen and bruising to the left arm and shoulder. These injuries are consistent with the belted driver being in the seat when the vehicle collision occurred. It therefore appears more probable than not that Mr. Morris would have been alive until the occurrence of the very severe impact that knocked the cab of the Kenworth tractor off its frame.
